Coat of paint at the Dresden Zwinger – background and conservation method

Barevné provedení drážďanského Zwingeru – historie a konzervační metoda

Stephan Heisig

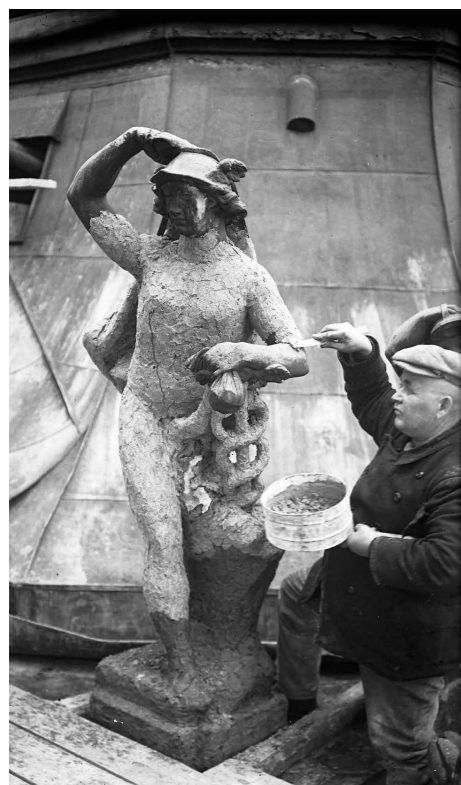
Fig. 2 Leaching of colour layers from the sculpture Hermes at Kronentor attic. [H. Ermisch, Landesamt für Denkmalpflege Sachsen, 1925]

The measures conducted between 1924 and 1936 were in line with the aesthetic preference of the early 20th century for a natural stone tooled appearance, justified by the obvious stone damage, which was incorrectly attributed solely to the sealing oil paint.¹⁶¹ Thus, the credo "never again paint on the Zwinger!" became popular. All facades and sculptures were to be stripped of their colour layers and the entire complex appeared completely with a natural stone surface for the first time in its history. During this restoration phase from 1924 to 1936, a strongly alkaline paste, later known as "Zwinger paste," was used to leach all the sculptures and the entire facade surface. (Fig. 2) The paste consisted of caustic soda, slaked lime and soap, among other ingredients. After a reaction time of up to 24 hours, it was removed along with the layers of paint and rinsed off with plenty of water, whereby the active agents were unintentionally carried deeper under the stone surface and deposited there. Immediately after drying the substances became noticeable, particularly on the exposed stone sculptures, in the form of efflorescence, which was mainly due to reactions with the caustic soda solution. The following reactions are related to the sulfur dioxide-containing air that prevailed at the time due to coal combustion in households and industry: When the sodium hydroxide came into

contact with the CO₂ in the ambient air, it initially converted to sodium carbonate, which caused long term reactions with the flue gases and sulfuric acid rainwater (SO₂) to form sodium sulfate.¹⁷¹ This sulfate compound is known as one of the most harmful stone damaging salts. By leaching the entire facade of the Zwinger, the sodium sulfate accumulated in the whole stone structure. Until today the salt is particularly noticeable in the form of spalling due to high pressure of periodic salt crystallization. Thus, with the best of intentions to protect the stone from rapid decay, another, no less fatal cause of damage was created.

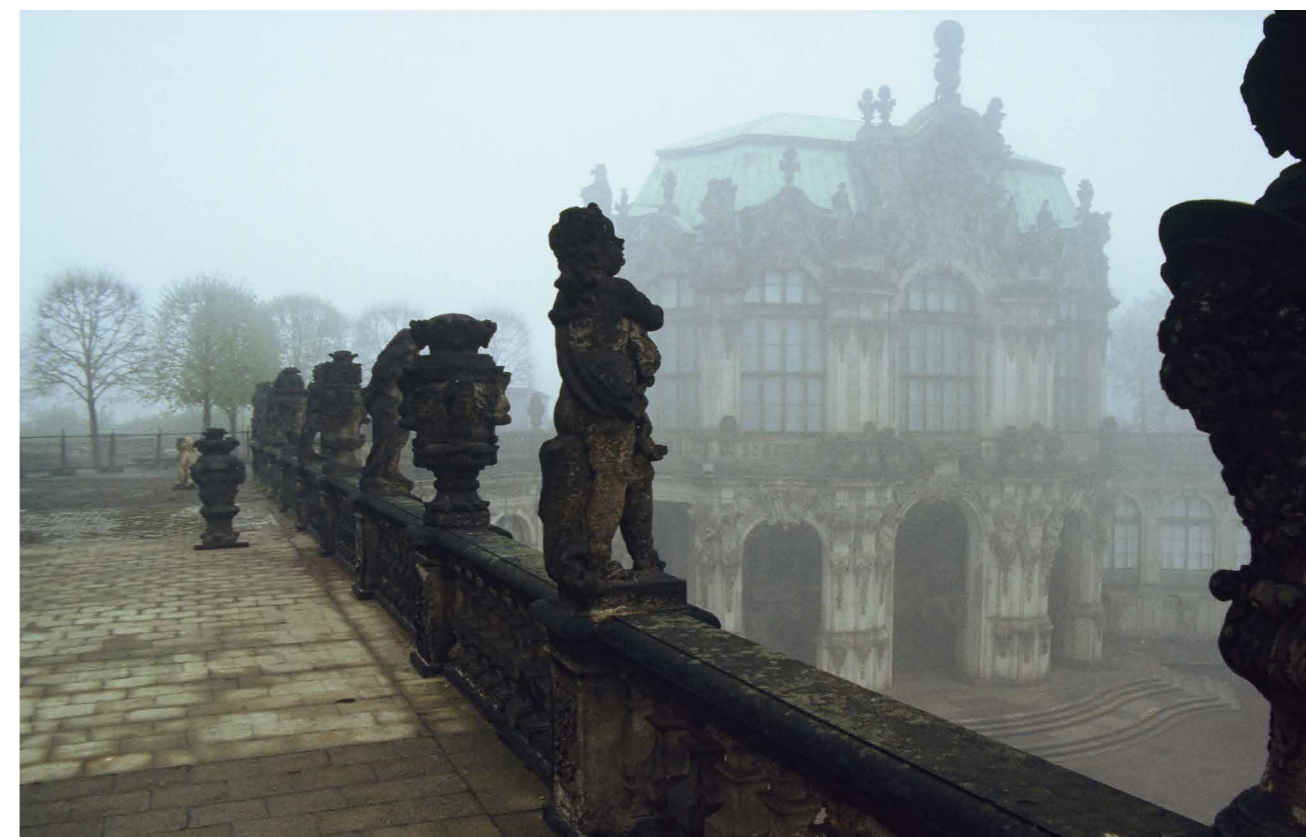
Fig. 3 Wallpavillon and black patinated balustrade sculptures. [Zwingerbauhütte, 1992]

the aforementioned salt-induced damage, the formation of gypsum crusts and also the typical black patina on Elbe sandstone. Although the incompatible oil paint had been removed, it now became apparent that the unprotected Elbe sandstone was exposed to rapid erosion and patination. Without continuous maintenance, critical conditions developed again over the course of the 1970s and 1980s, particularly in the stone substance of the most weather exposed architecture – the attic, balustrades, and sculptures – which necessitated the development of a comprehensive conservation concept

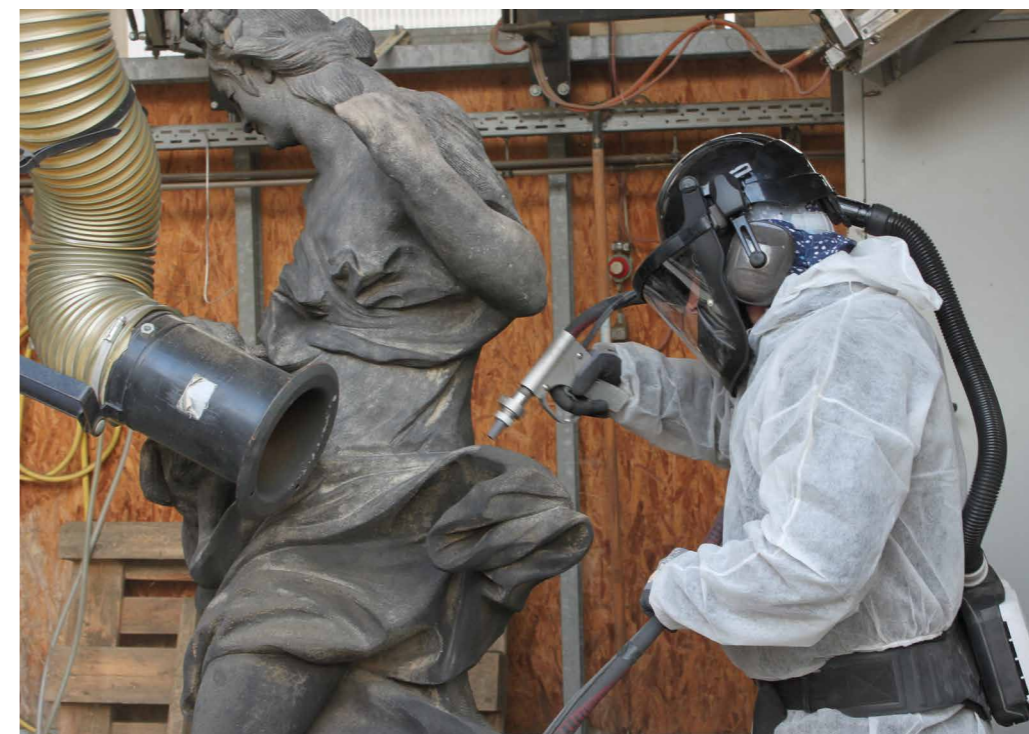
Fig. 4 Low pressure glass powder blasting in order to carefully thin compacted patina areas. [Zwingerbauhütte, 2016]

Vases and sculptures can be removed and transferred from the building to the Zwingerbauhütte workshop. In preparation for the conservation, the black patina surface of a sculpture is thinned by blasting it with glass powder. The air pressure is kept low at three bar to prevent abrasion of the tooled surface. In the careful process the patina film is thinned solely on the exposed tops of the surface quartz grains. (Fig. 4) Why does the patina have to be thinned first?

Over decades up to centuries of formation, the patina creates a near-surface compaction with far lower water permeability than the unpatinated brighter stone surfaces. On objects exposed to rain, completely different sorption behaviors occur often within the same object. Thus, the purpose of powder blasting is not cleaning, but preparing the sculpture for the water bath desalination. With this method, the sculpture is placed in a bath of demineralized water. The water dissolves and extracts the salt from the stone. Since the compacted patina areas on the sculpture was thinned beforehand, an equal charge balance in the water bath process is improved. The increasing salt content of the water is measured using conductivity. Based on the salt concentration of the water, the salt amount extracted from the stone can be calculated. After two weeks, the salt containing water is exchanged. The process can be repeated in up to five cycles until the salt content in the stone is reduced to a harmless level.

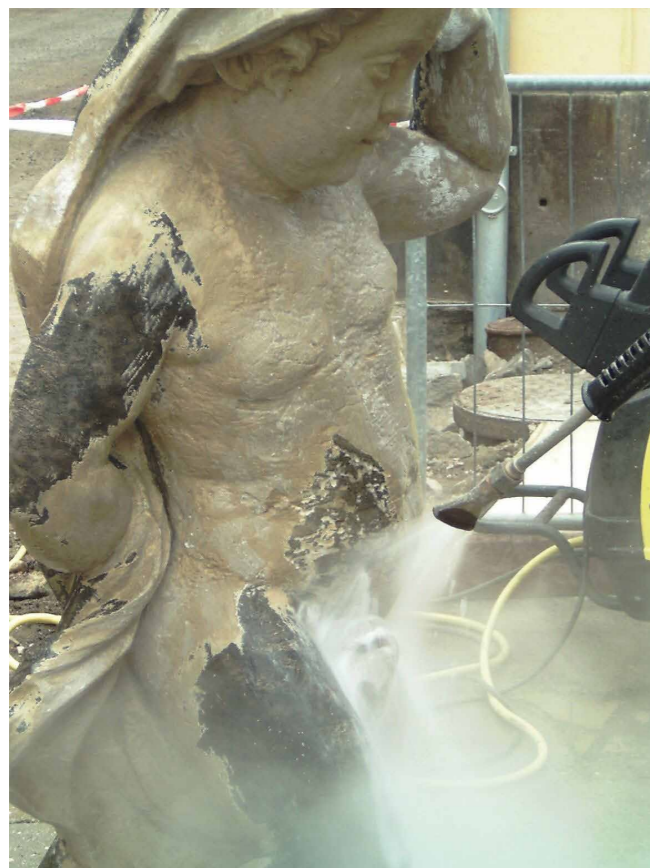
Fig. 5 Reversible silicone resin paint layer, removed in steam jet method before regularly renewal. [Zwingerbauhütte, 2005]

changes from -18°C to 50°C .^[13] Since no hydrophobic depth impregnation is used prior to application in order to ensure vapor diffusion openness, the hydrophobicity is limited to the paint layer. The non-invasive application also ensures the reversibility of the entire protection system. (Fig. 5) Reversibility plays a decisive role since the paint layer must be renewed at regular intervals of 10 to 20 years, depending on weather exposure. The paint layer can be removed from the stone surface using steam jet or low-pressure sand blast method.

The coated sculptures are regularly inspected and maintained. Wet cleaning can be used to easily remove dirt and biogenic growth from the paint layer. Small imperfections should be retouched. Depending on the rain exposure of the sculptures, the thickness of the paint layer may be reduced by chalking off over a period of 10 to 20 years to such an extent that a complete renewal of the paintwork may be necessary. To this end, the entire surface is cleaned, imperfections in the paintwork are filled, and a new single-layer paintwork is applied.

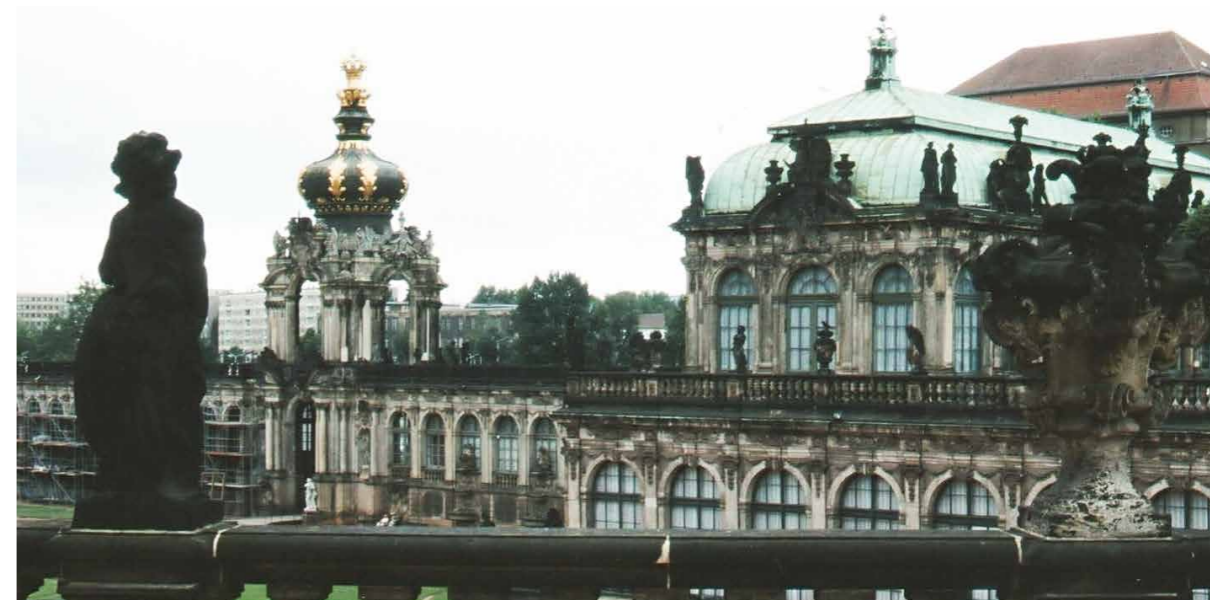
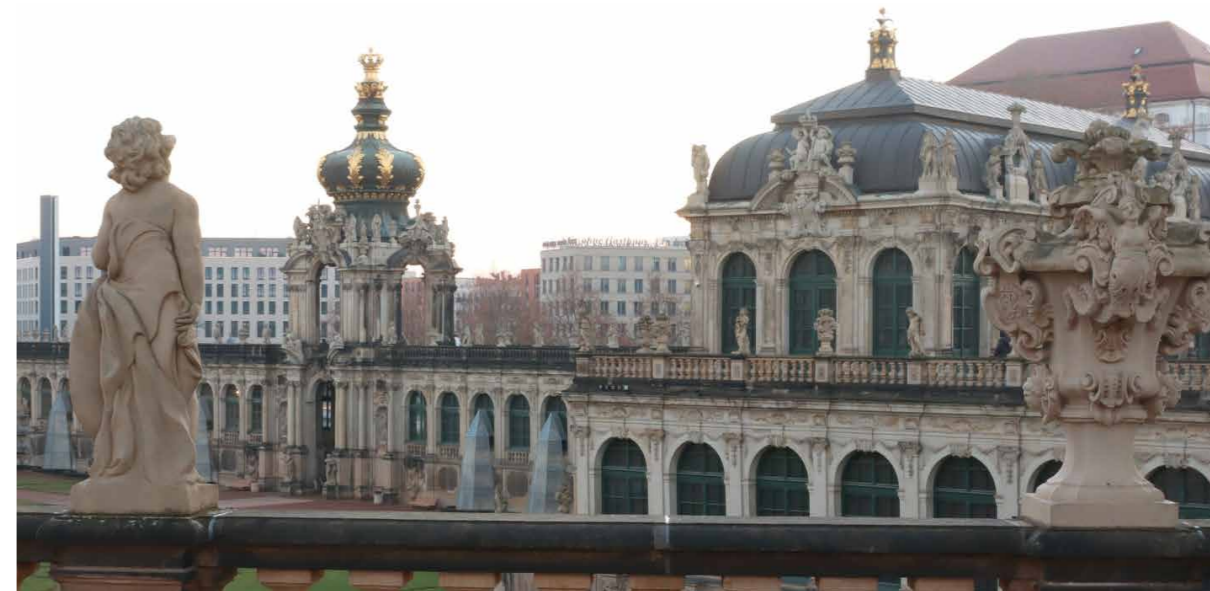
Fig. 6a, b Facade proportions influenced by patinated architecture, below: restored attic and balustrade sculptures. [Zwingerbauhütte, 1999 / 2025]

The overall conservation goal at the Zwinger is to preserve and protect the entire stone structure. However, protection should not anymore take the form of colouring the entire building. The coating with silicone resin is limited to the few areas (in relation to the entire building) where the sandstone is exposed to intense weathering: in the attic areas of the pavilions and on 516 weather exposed sculptures. Prior to the coating measures up to the early 2000s, these areas stood out sharply from the rest of the facade surfaces due to their black colouration. Viewed from a distance, in front of the copper roofs or the sky, they appeared merely as two-dimensional silhouettes without any perceptible plastic details. In addition to the conservation goal, the coating also fulfills the aesthetic requirement of making the rich detail of the sculptural decorations visible.

In terms of painting technique, the coating does not aim to create the appearance of a new glaze, but rather to match the black patinated areas to the light natural stone colour of the facade surfaces.^[14] The decisive factor is the exact reproduction of the various colour hues of aged but not patinated sandstone, which appear on the building in warm ochre tones with subtle nuances of red, gray and brown. To counteract the monotony of a new coat of paint, individually blended hues are applied to larger pieces such as vases and sculptures, fading into one another without creating an illusionistic imitation of sandstone. By adjusting the hues, transitions from coated to uncoated surfaces can also be created on individual sections of the facade, which merge imperceptibly into one another when viewed from a distance. This method harmonizes the overall architecture and reveals the intended proportions of the facades. (Fig. 6) It is not the colour, but the plasticity of the architecture that should come to the fore, so that the Zwinger reapproaches the design intention of a cheerful baroque architecture.
